Atlas

Water Quality

JAMAICA

— 2019 —

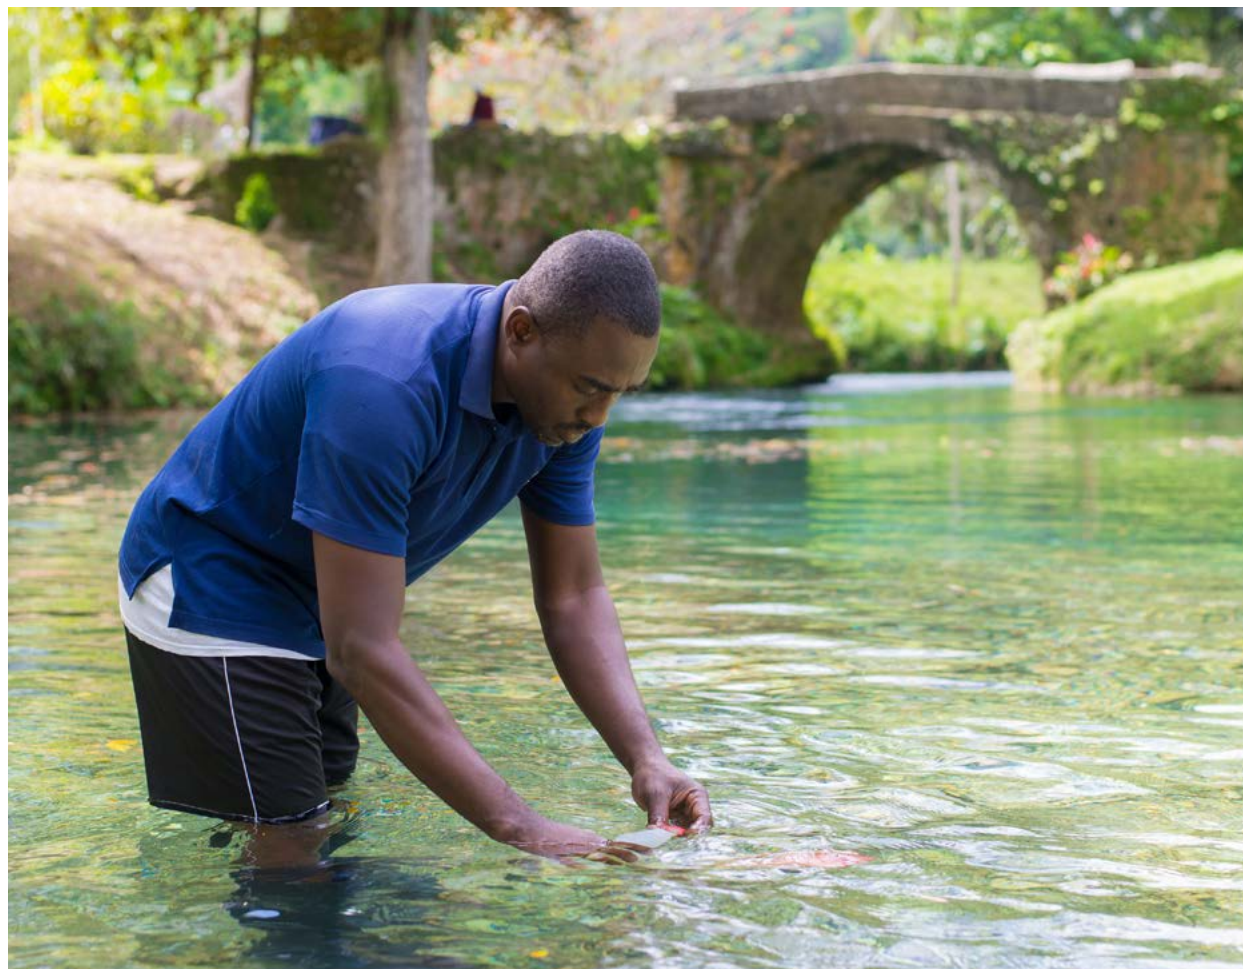
1.0 Basin I - Blue Mountain South Hydrologic Basin

The Blue Mountain South Hydrologic Basin encompasses the parish of St. Thomas.

The Blue Mountain South Hydrologic Basin has been divided into five sub-basins: Yallahs River, Morant River, White Horses, Plantain Garden River and Port Morant. The basin is drained by a network of rivers traversing the mountains (basement aquiclude – low permeability cretaceous volcanics) in the western, central and eastern sections of the basin, and across the plain towards the southern coast.

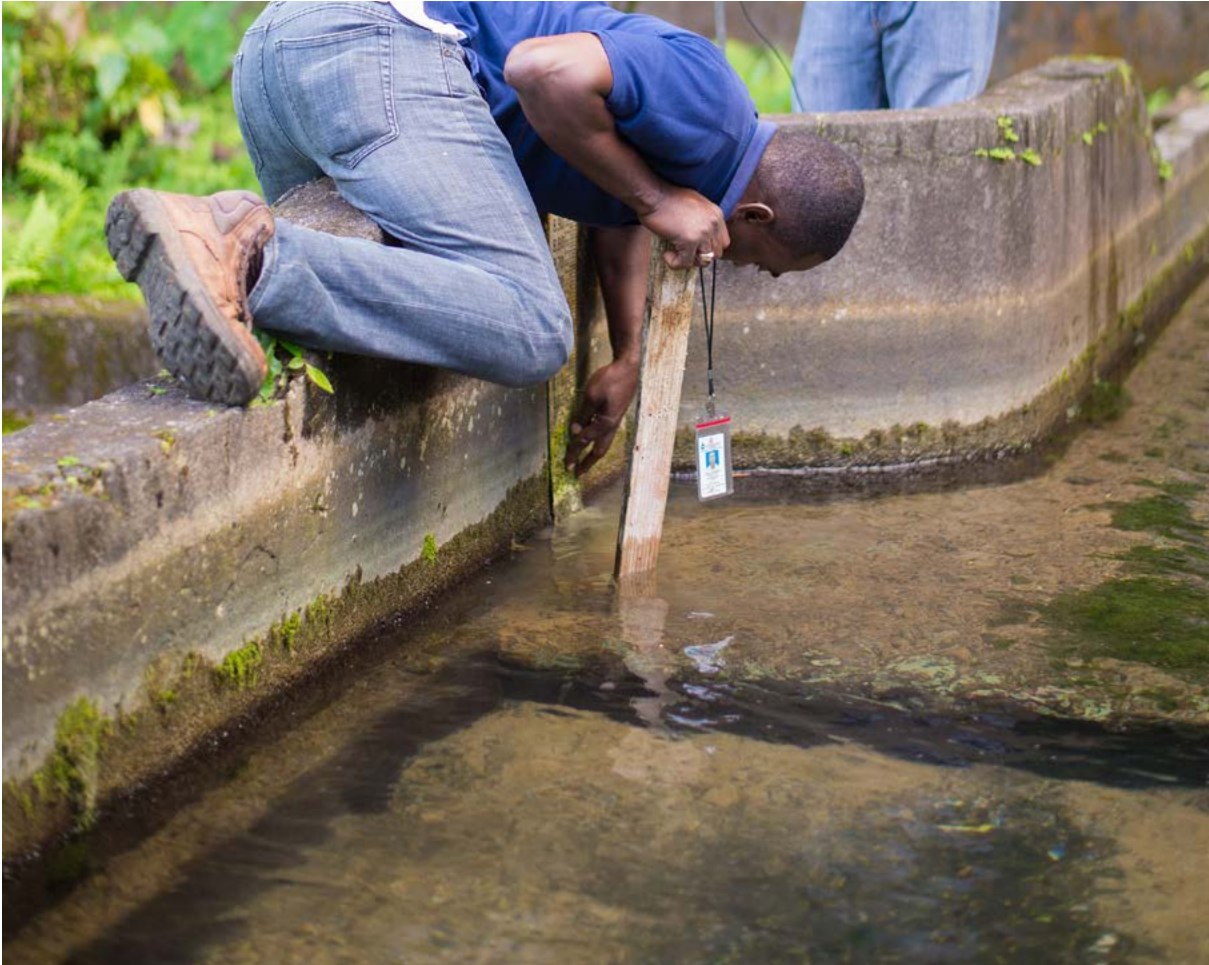
2.0 Basin II- Kingston Hydrologic Basin

The Kingston hydrologic basin includes the parishes of Kingston and St. Andrew, Jamaica's largest and most densely populated urban center. For water management purposes, the Kingston Basin has been divided into four sub-basins; Hope River, Cane/Mammee River, Chalky/Bull Bay and the Liguanea Plains. The basin is drained by a network of rivers flowing over mountains (basement aquiclude – low permeability cretaceous volcanics) in the eastern section of the basin, and by a system of concretized gullies across the plain towards the southern coast.

The water resources within the Kingston Basin comprise of groundwater from the limestone and alluvium aquifers of the Liguanea Plains and surface water from the other three sub-basins: Hope, Cane/Mammee and Chalky/Bull Bay.

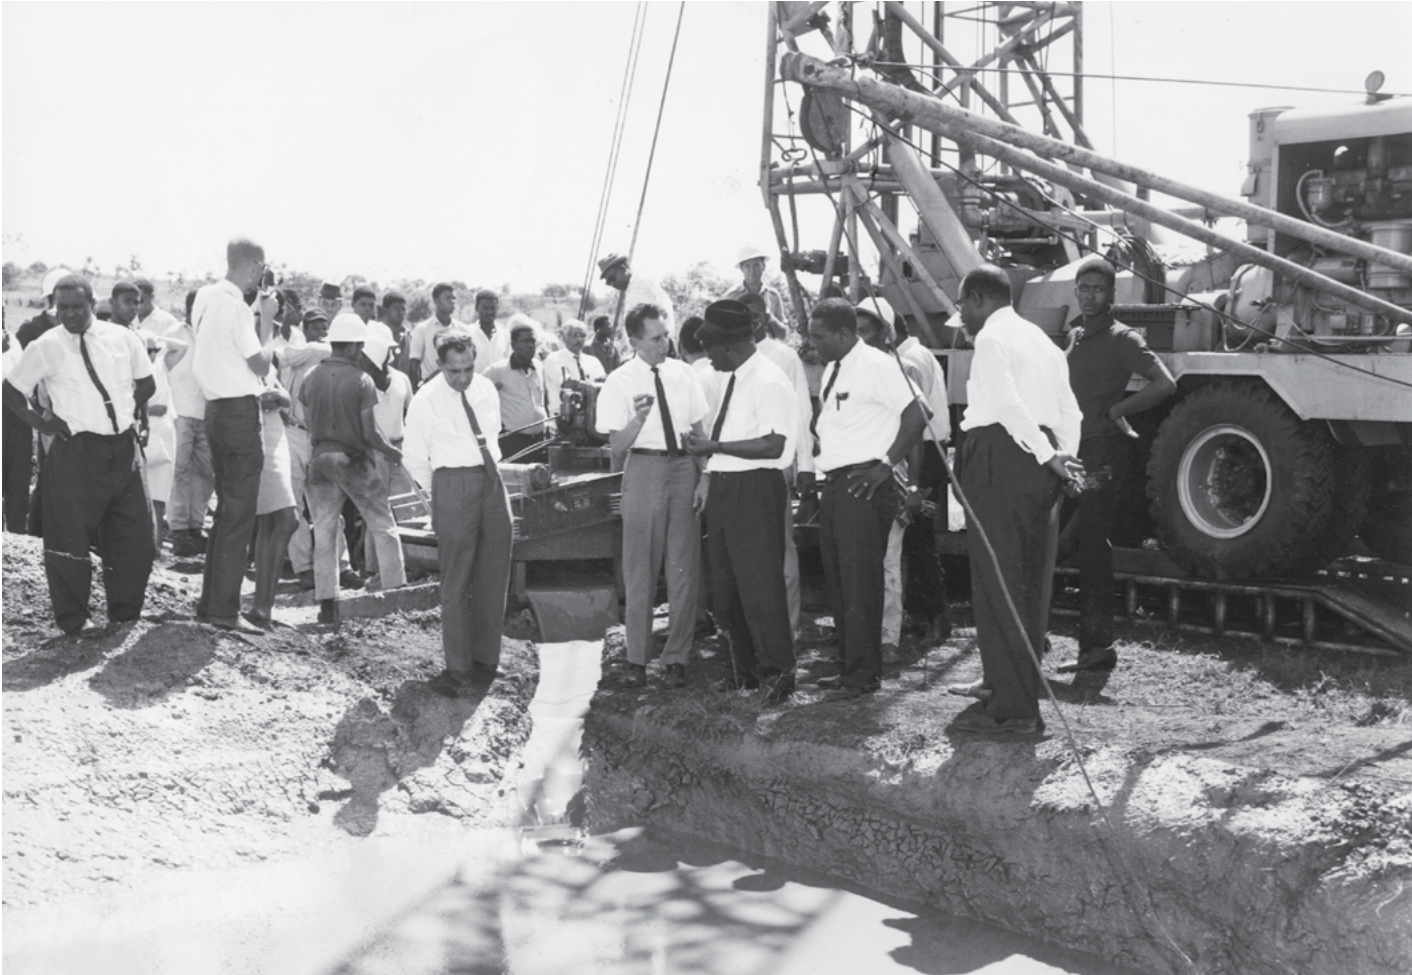
3.0 Basin III- Rio Cobre Hydrologic Basin

The Rio Cobre Hydrologic Basin extends across St Catherine, Northern Clarendon, Southern St Ann and parts of Kingston. The sub basins located within the Rio Cobre are the Upper Rio Cobre, the Lower Rio Cobre, Hellshire, Salt Island Creek, Bowers Gully and Coleburns Gully.

The basin consist predominately of white limestone, interbedded with alluvial and superficial deposits. The western parts of the basin have outcrops of Cretaceous volcanic rock and the eastern boundaries have granodiorite. The basin is drained mainly by the Rio Cobre at Hunts Bay.

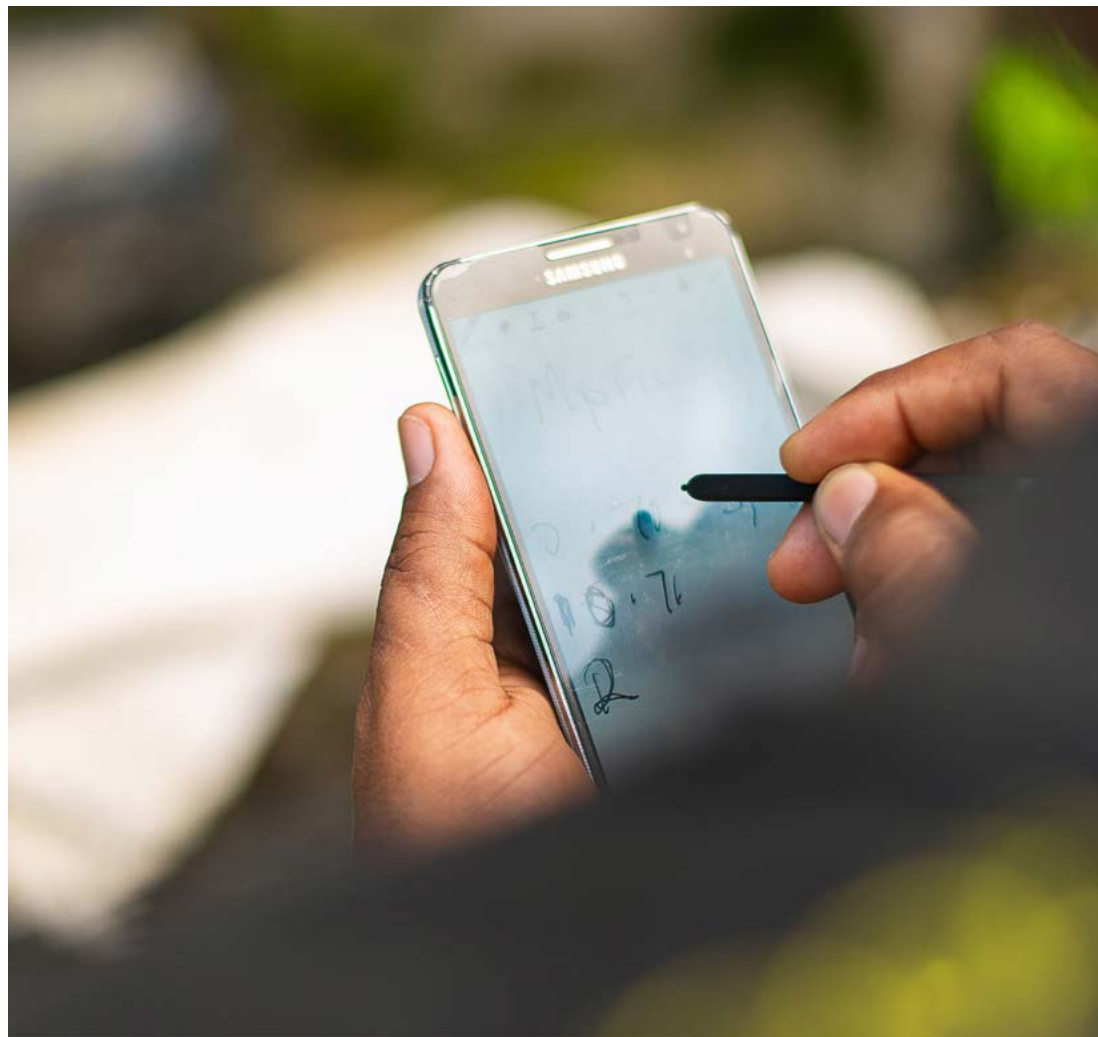
4.0 Basin IV Rio Minho Hydrologic Basin

The Rio Minho Hydrologic Basin spans the expanse of Clarendon, Manchester and the western area of St Catherine. The Rio Minho Basin is divided into seven (7) sub-basins for water management purposes and because of its Hydrologic and topographical characteristics. These sub - basins are Upper Rio Minho, Lower Rio Minho, Milk River, Alligator Hole, Portland Ridge, Cockpit Springs and Bowers River.

The most northern regions of the basin are comprised of primarily cretaceous volcanic and are superimposed by younger yellow limestone rocks. Centrally, the basin is comprised of white limestone which takes up the largest portions of the basin. The southern regions are made of alluvial deposits underlain by white limestone with white limestone outcrops. The white limestone underlies the whole of the Clarendon plains and crops out in the Manchester Highlands to the west, the Mocho Mountains to the north and the Harris Savanna and Brazille to Mountains to the east. These areas account for most of the recharge to the aquifer (WRA 1974, Development and Management of Water Resources Jamaica Rio Minho - Milk River Basin).

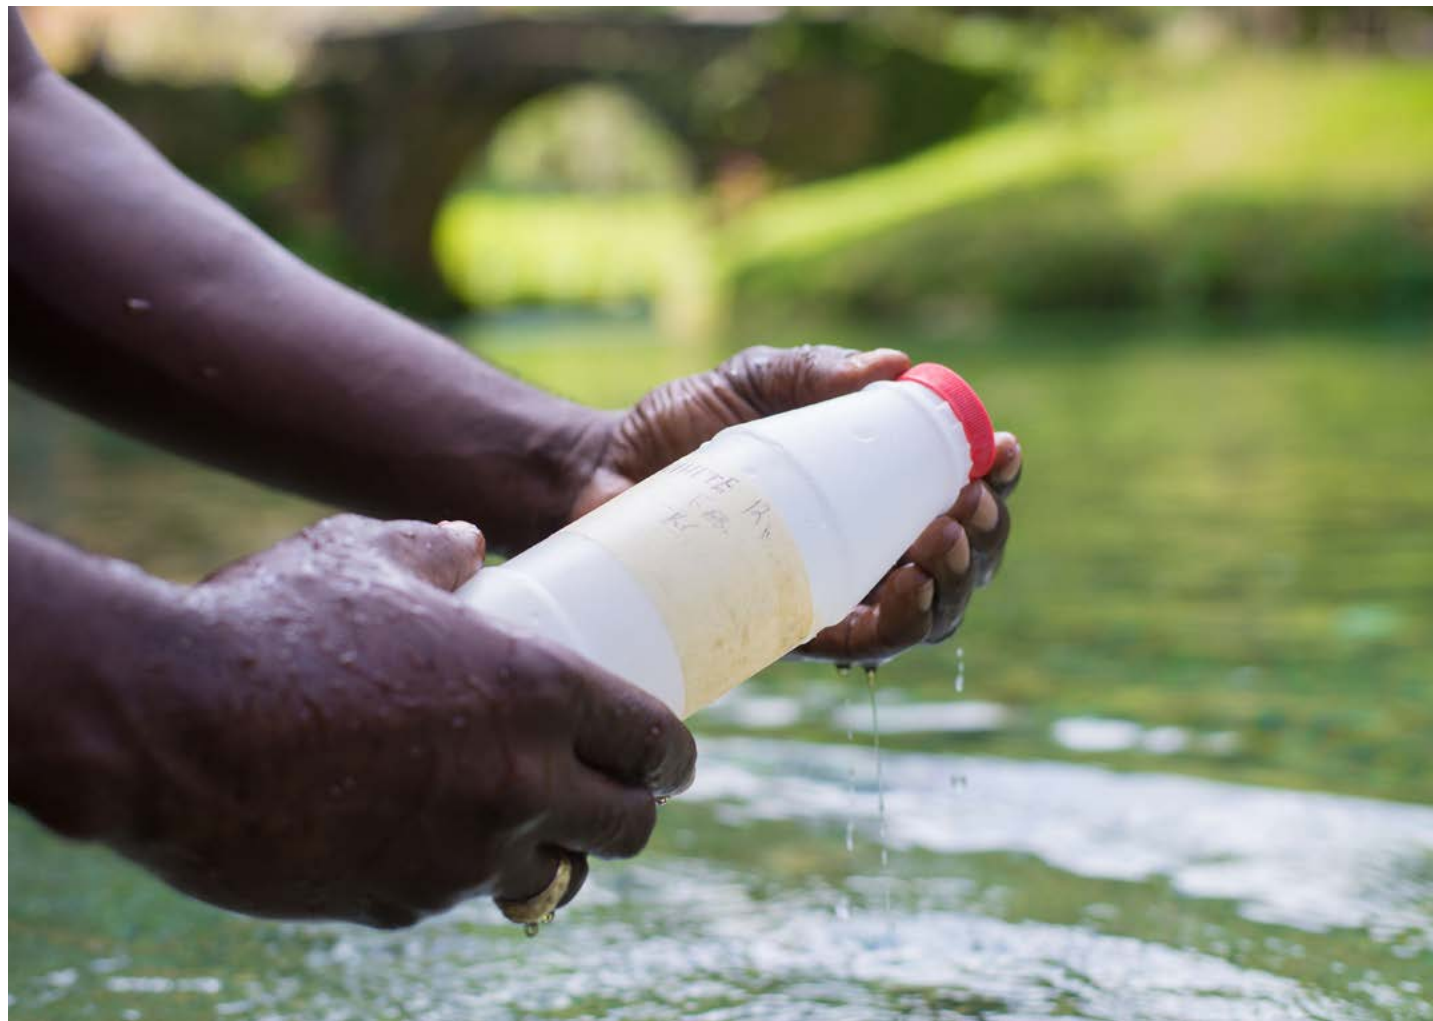
5.0 Basin V Black River Hydrologic Basin

The Black River Basin primarily covers the parish of St Elizabeth with sections of the parish of Manchester, Trelawny and St James also included. The Black River Hydrologic basin is divided into four sub basins: Bull Savannah, Pedro Plains, Upper Black River and Lower Black River.

The basin is comprised of white limestone (Newport Formation) which takes up the largest portion of the basin, overlain by alluvial deposits formed by the active fluvial system present. The area is primarily drained by the Black River which flows from the north to south west. Ground water has a general southern flow direction towards the coast

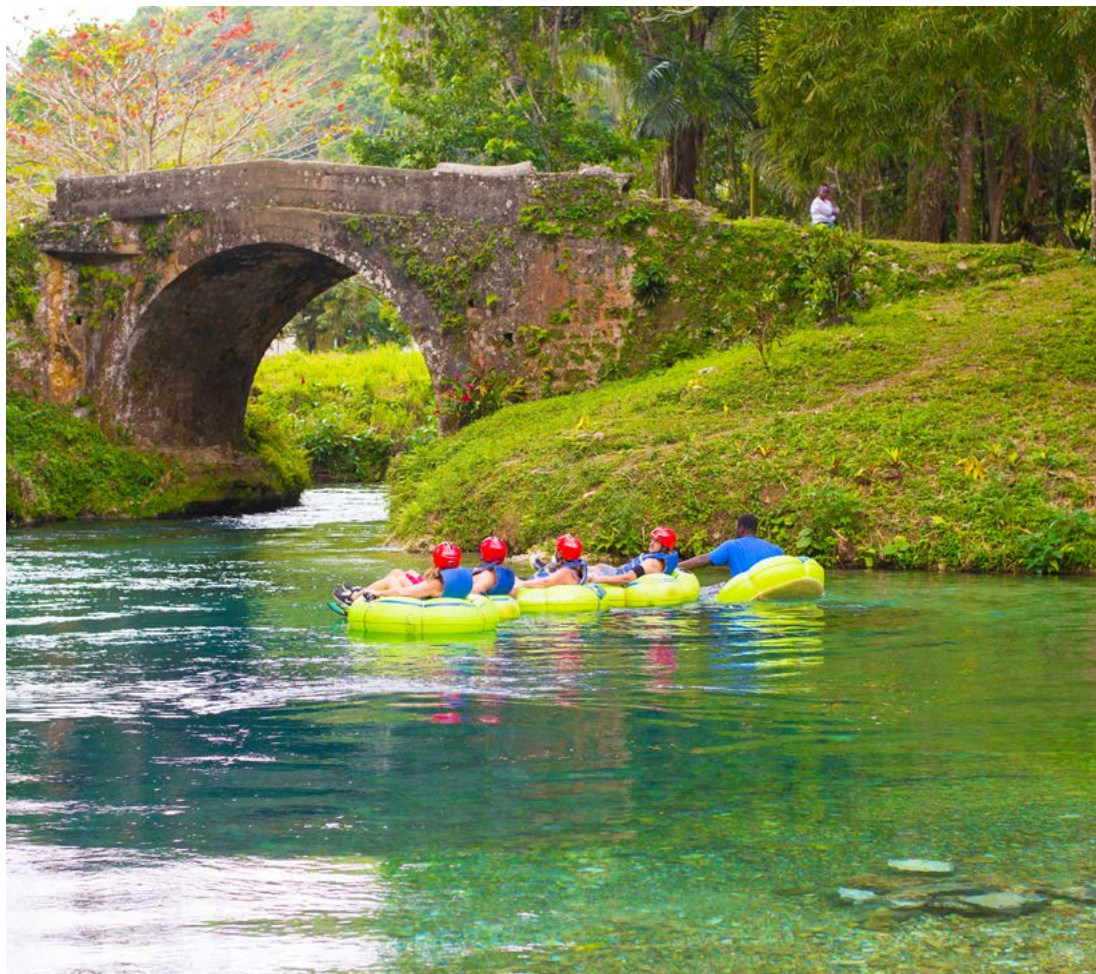
6.0 Basin VI Cabarita Hydrologic Basin

The Cabarita River is the sixth basin and is located to the south west of the island. The basin is located in the parish of Westmoreland, St Elizabeth and parts of Hanover. For water management purposes, Cabarita River Hydrologic Basin has been divided into four Watershed Management Units (WMU): South Negril-Orange River, New Savannah River, Cabarita River and Deans Valley River. These WMUs are further divided into five sub-WMUs: Great Morass, Orange River, South Negril River, Deans Valley and Goat Gully-White Horse Gully. The basin is split with Alluvial and superficial deposits to the west of the basin, sitting on top of white limestone that is exposed to the east of the basin. This geological bedding is pervasive throughout the basin, with the exception of the small Green Island Inlier at the border of the Cabarita River Basin and the Great River Basin.

The basin is further drained by a network of springs and rivers traversing over alluvium aquiclude in the central section of the basin, and to a lesser extent over limestone aquifer to the eastern section flowing south towards the coast. The primary drainage direction is to the south via the Cabarita River which drains the southern section of the Lucea River and Great River WMUs. The water resources within the Cabarita basin are comprised of groundwater from limestone aquifers and surface water from the rivers and springs that drain the five sub-WMUs.

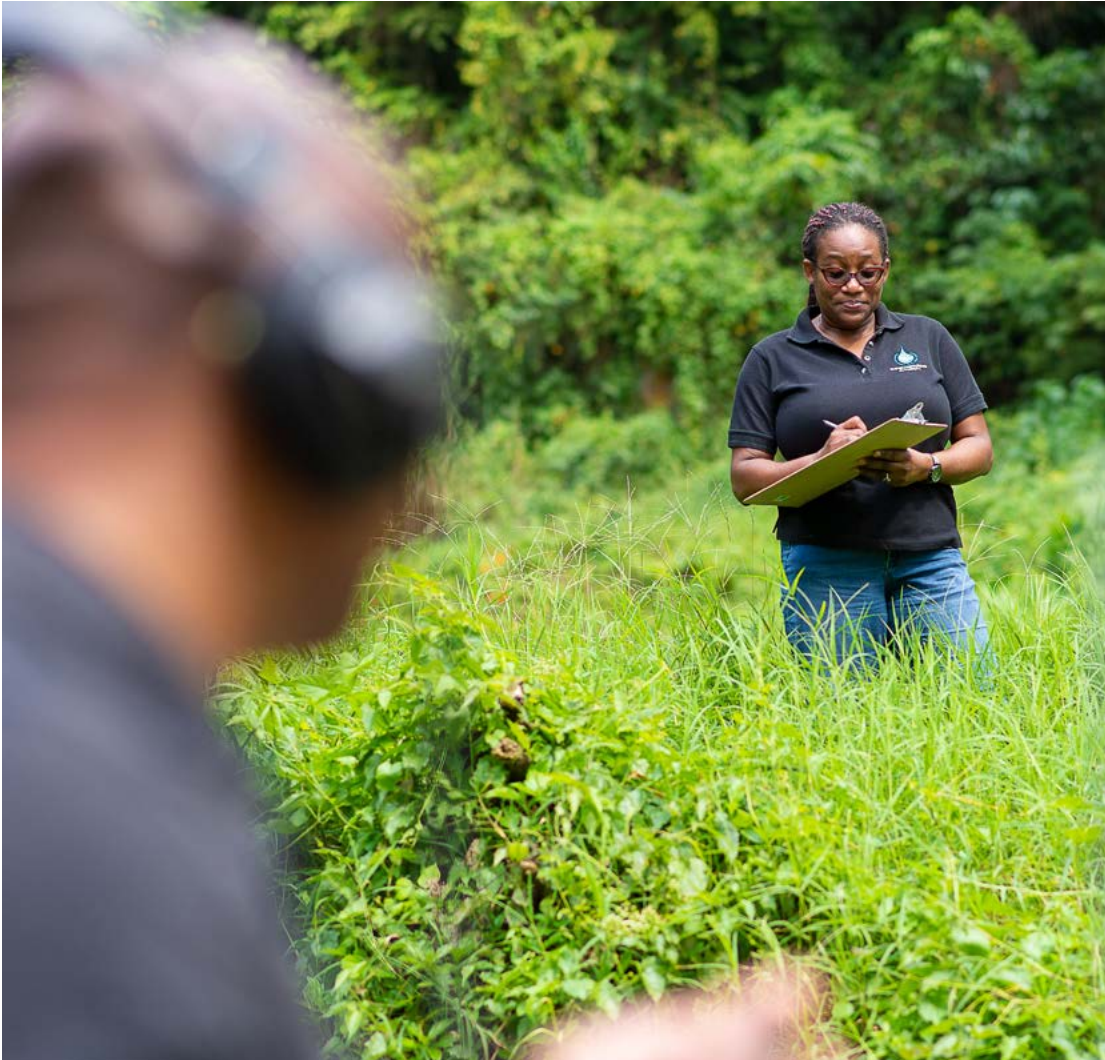
7.0 Basin VII Great River Hydrologic Basin

The Great River Hydrologic Basin includes the parishes of St. James and Hanover. For water management purposes Great River Hydrologic Basin has been divided into three Watershed Management Units (WMU): Lucea River, Great River, and Montego River. These WMUs are further divided into eight sub-WMUs: Green Island River, Lances River, Lucea West River, Mosquito Cove, Great River, Flint River, Montego River and Ironshore.

The water resources within the Great River basin are comprised of groundwater from limestone aquifers, and surface water from the rivers and springs that drain the eight sub-WMUs.

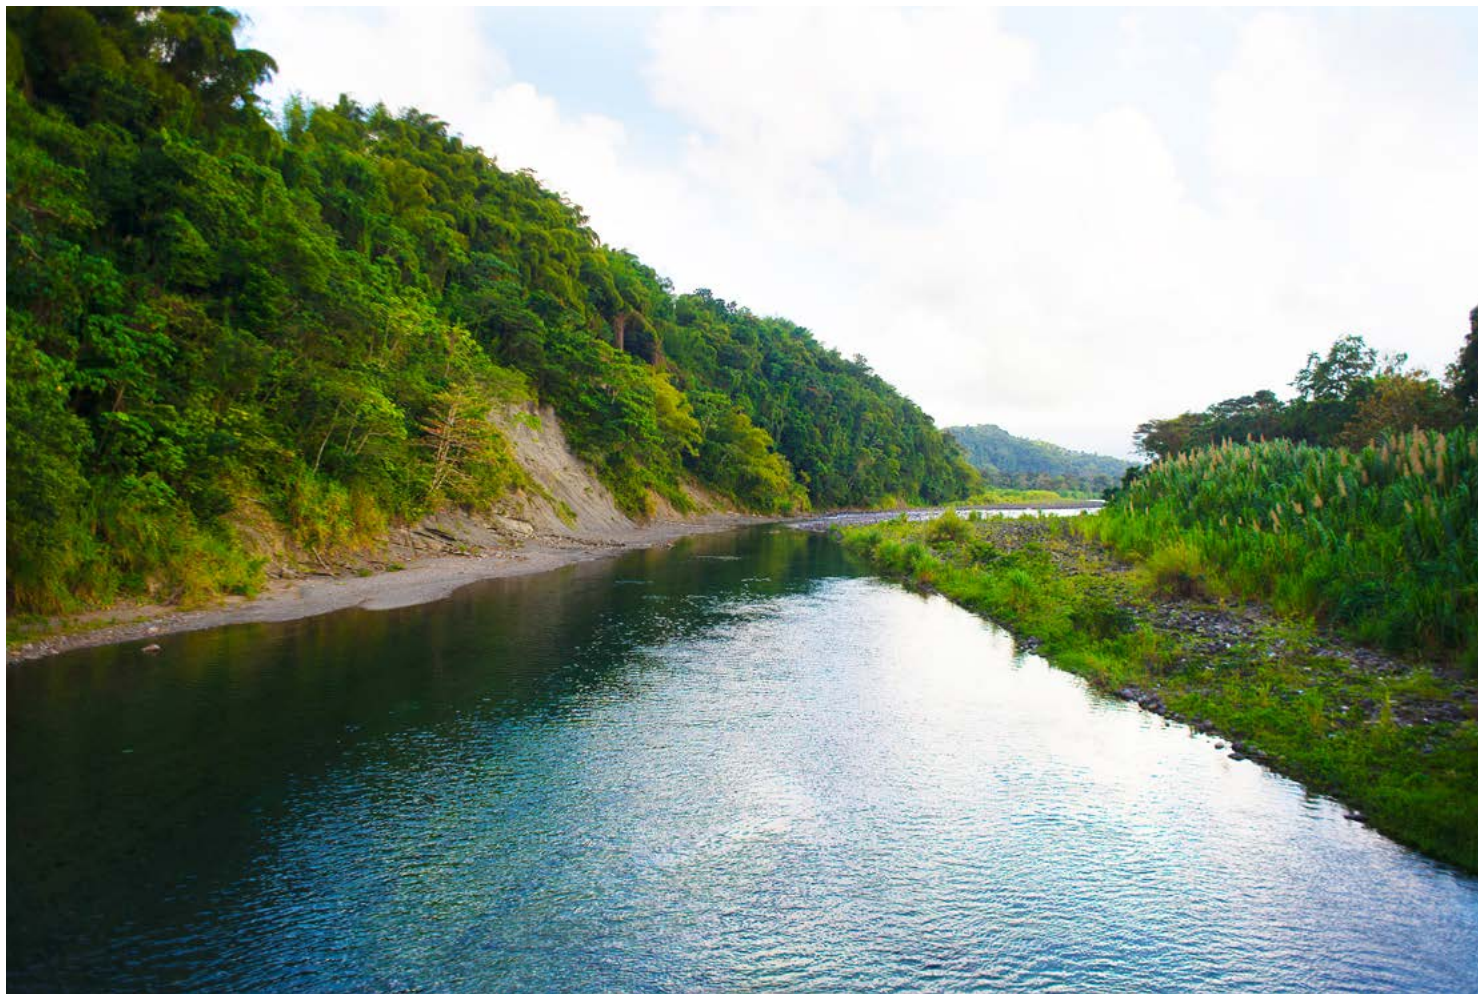
8.0 Basin VIII Martha Brae River Hydrologic Basin

The Martha Brae Hydrologic Basin includes the parish of Trelawny. The basin is drained by a network of rivers flowing over mountains (basement aquiclude – low permeability Cretaceous volcanics) in the western, central and eastern sections of the basin across the plain towards the northern coast.

The water resources within the Martha Brae Basin comprise of groundwater from alluvium aquifers and surface water from the rivers that drain the several sub-basins.

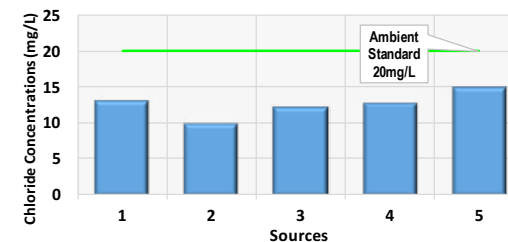
Graph 78: Martha Brae River Basin Chloride Levels in Surface water

As shown in Figure 123 and Graph 78, the surface water sources within the Martha Brae basin predominantly indicated excellent water quality for chloride. All the sources (100%) sampled indicated chloride quality within the National Ambient Water Quality Standard of 20mg/L.

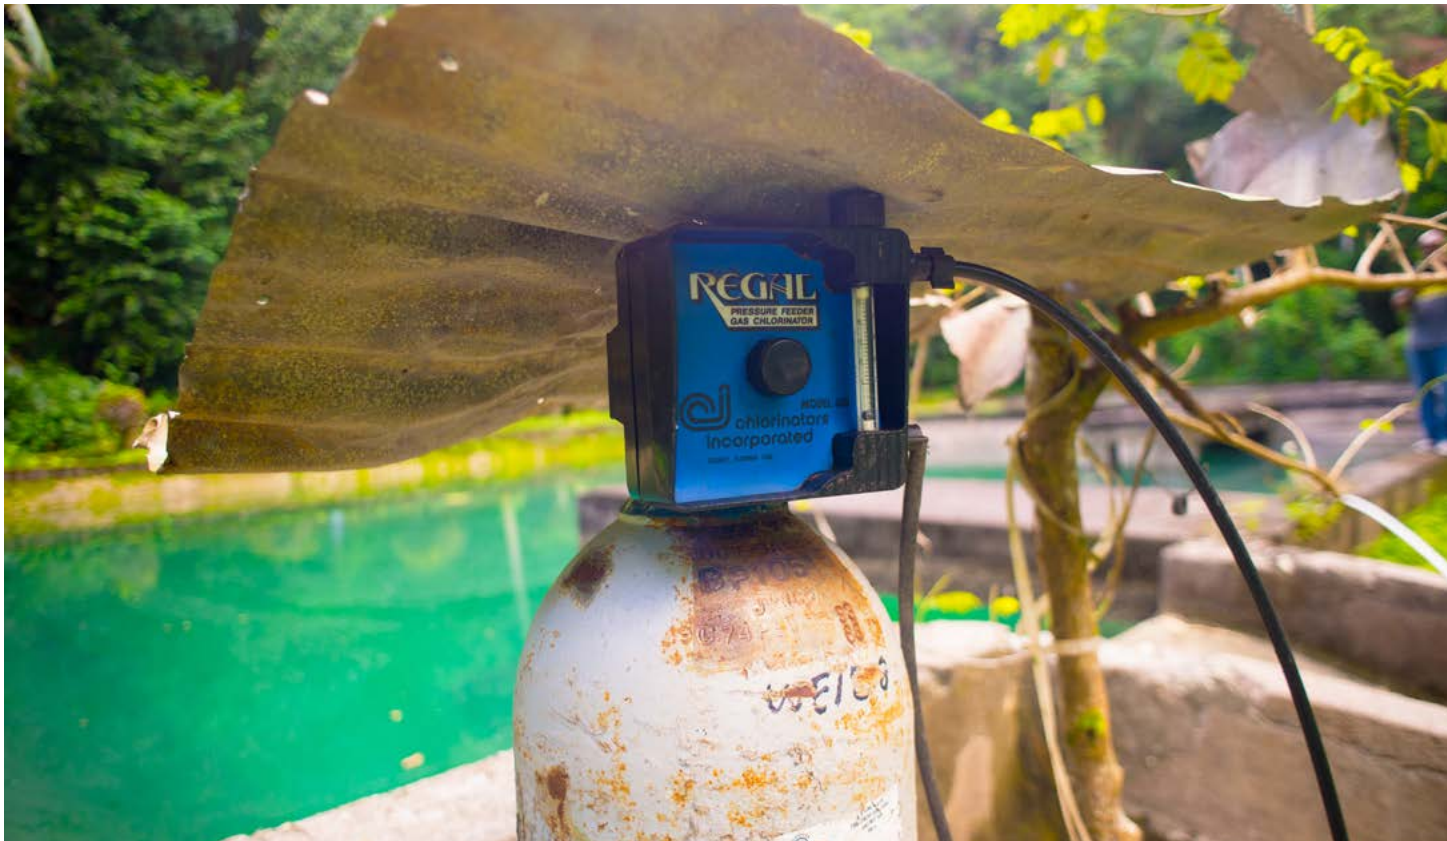
9.0 Basin IX Dry Harbour Mountain Hydrologic Basin

The Dry Harbour Mountain Hydrologic Basin includes the parish of St Ann. For water management purposes, this Hydrologic Basin has been divided into two Watershed Management Units: Rio Bueno and White River.

The basin is drained by a network of rivers flowing over mountains (basement aquiclude – low permeability cretaceous volcanics) in the western, central and eastern sections of the basin towards the northern coast.

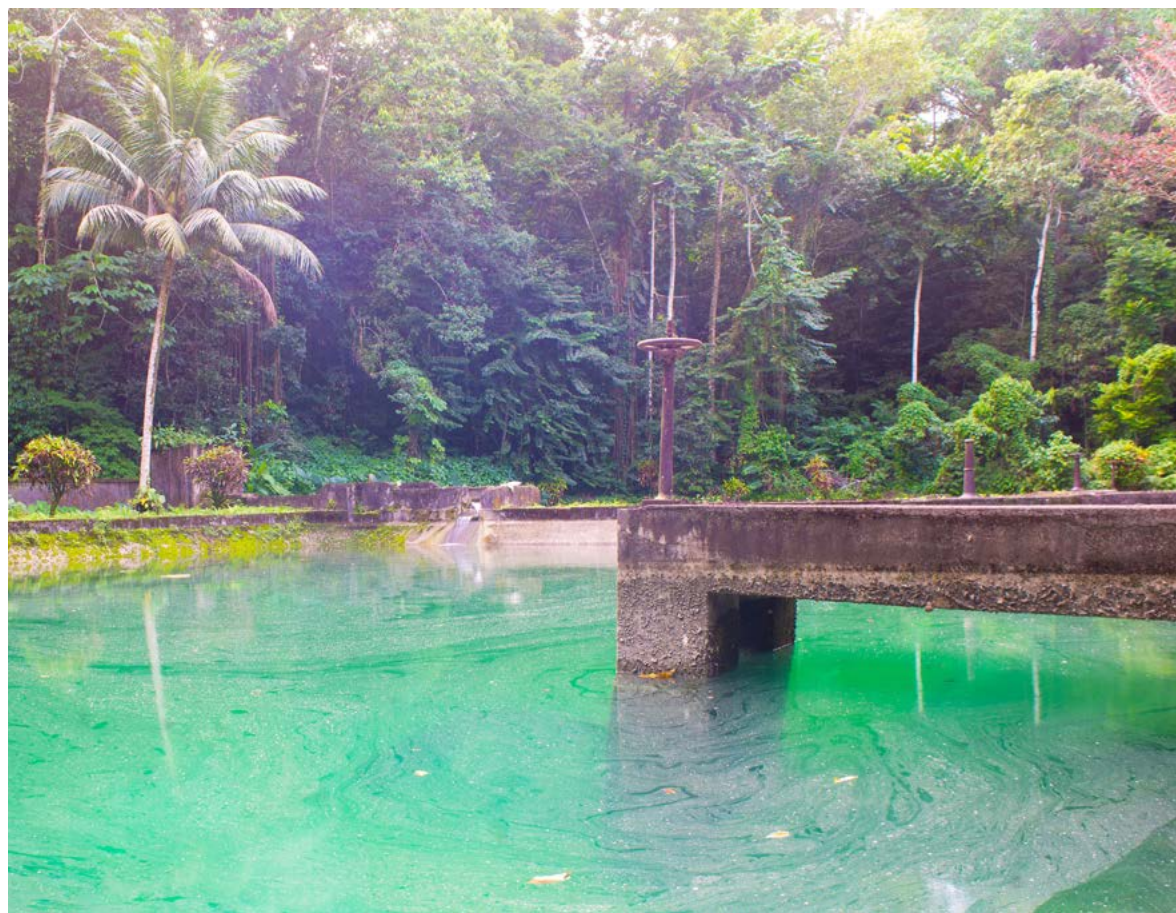
10.0 Basin X Blue Mountain North Hydrologic Basin

The Blue Mountain North Hydrologic Basin includes the parishes of Portland and St. Mary. For water management purposes, the Blue Mountain North Hydrologic Basin has been divided into thirteen sub-basins: Rio Nuevo, Oracabessa River, Pagee River, Wagwater River, Pencar River, Dry River, Buff Bay River, Spanish River, Swift River, Rio Grande, Town Gully, Priestman's River and Driver's River. The basin is drained by a network of rivers flowing over mountains (basement aquiclude – low permeability Cretaceous volcanics) in the western, central and eastern sections of the basin towards the northern coast

The water resources within the Blue Mountain North basin are comprised of groundwater, the limestone aquifer and surface water from the rivers that drain the thirteen sub-basins: Rio Nuevo, Oracabessa River, Pagee River, Wagwater River, Pencar River, Dry River, Buff Bay River, Spanish River, Swift River, Rio Grande, Town Gully, Priestman's River and Driver's River. Alluvial water within the basin is subsurface diversion of the river flows developed within the floodplain of the rivers.
